Leakage at Upper Mun Dam

Nibondh Saihom, Ruongrit Ammawat, Mondhian Kangsasitiam
and Thanu Harnpattanpanich
Royal Irrigation Department, Thailand

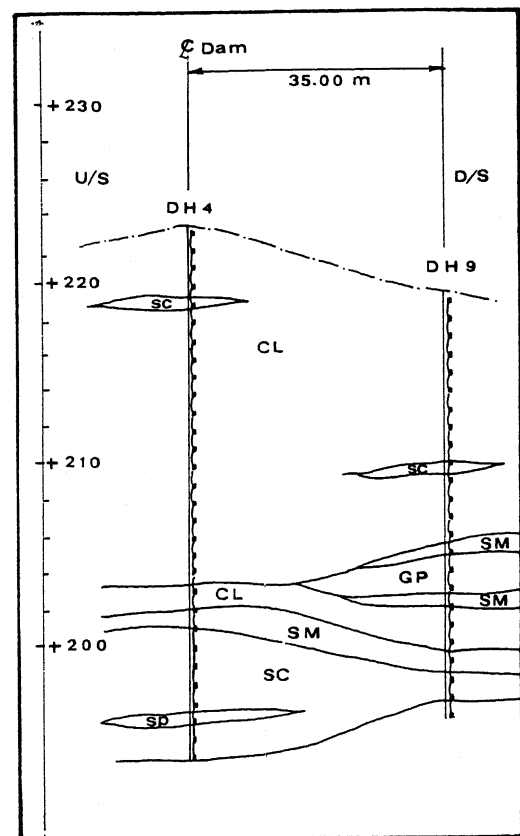
Fig. 8 Geologic Section at STA. 0+848

Based on the data of this soil investigation program in a number of relevant cross sections, geotechnical profiles were drawn up. They confirmed the original description of the foundation materials and did not reveal additional information on the embankment material. However many bore holes near the leakage location, for example at STA 0+848 (see Fig.8), indicated that the embankment was raised on thick permeable sand deposits with thin impervious clay of 1 to 2 meter in between. This thin clay layer might prevent the underseepage water to enter the horizontal blanket drain thus produced excessive uplift pressure against the downstream base of the dam.

The interpretation of the results of this geophysical survey led to an indication of the presence of holes in an area between about STA 0+785 and STA 0+830 and between about STA 0+855 and STA 0+880. The position of potential holes or cavities were suspected to be below Elv +208 m.

Also, the results indicated anomalies in the foundation material, around STA 0+830 below Elv +198 m. Further anomalies have been detected between STA 0+483 and STA 0+500 at the foundation level.
